**High-Volume Third-Party Remanufactured
Defender Steering Box**

Strip-Down and Component Analysis

02/12/2025

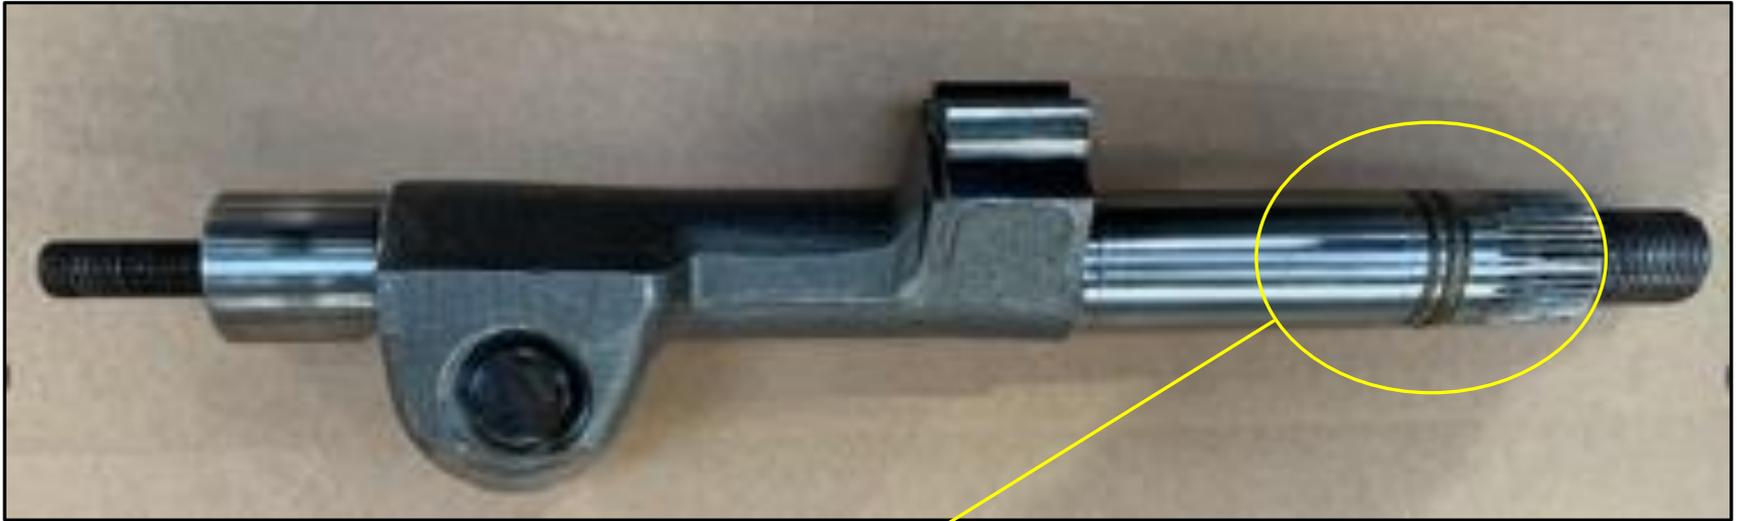
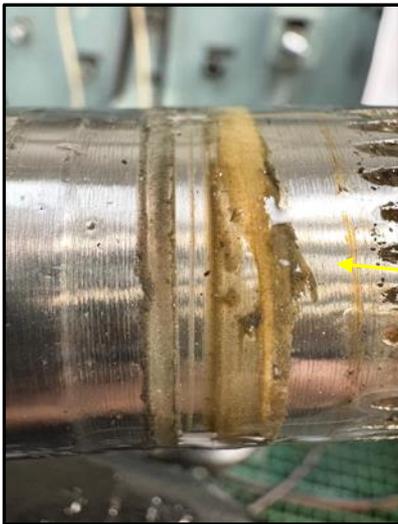
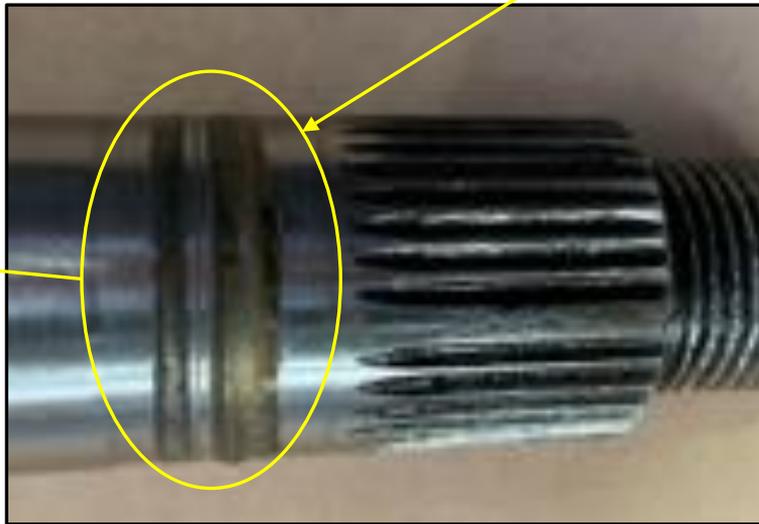
Sector Shaft Condition - Not Acceptable

**Sector shaft long end
ground down undersize to
removed corroded area
Issue: Seal engagement
reduced**

**Box needle bearing
contact area reduced
Sealing compound used
which has hardened
assumed to increase
sealing**

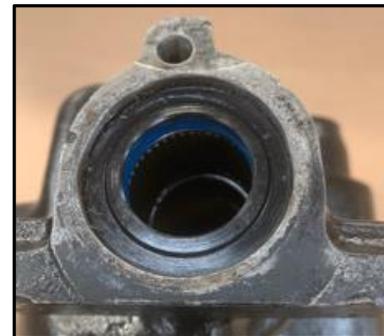
Sector Shaft Output Seal And Shaft Dimensions

Sector Shaft Output And Backup Seals Suppliers Not Known. See Measured Results Below.

Sector Shaft Output Shaft Sealing Area Ground Diameter Undersize. Practice Not Recommended For Durable Sealing

Sector Shaft Ground To Clean Up Sealing Area But The Seal used is Close to Original Sizes, Therefore Reduced Seal Engagement

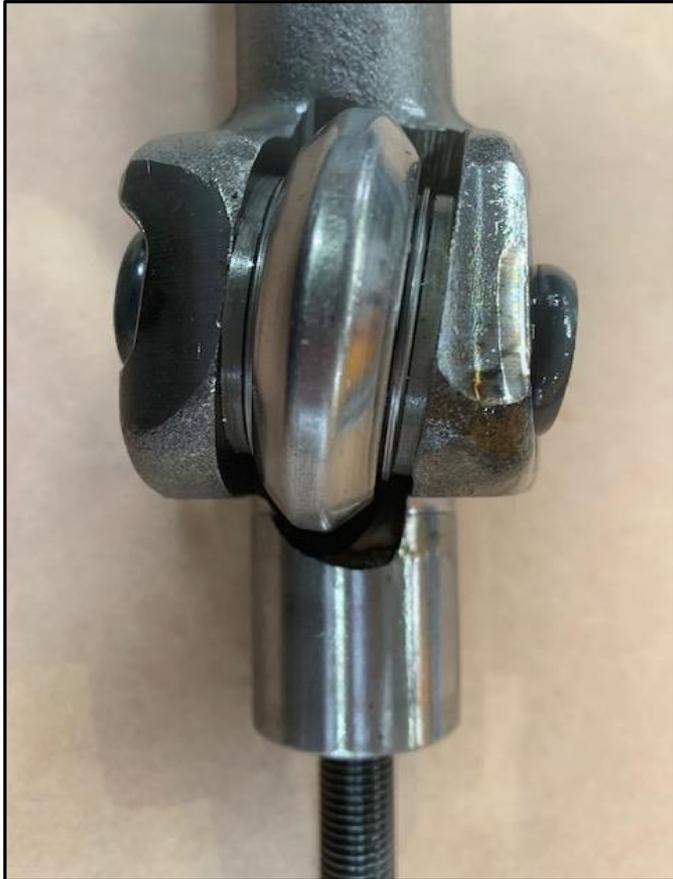
Sector Shaft Condition

Follower Assembly No Issues

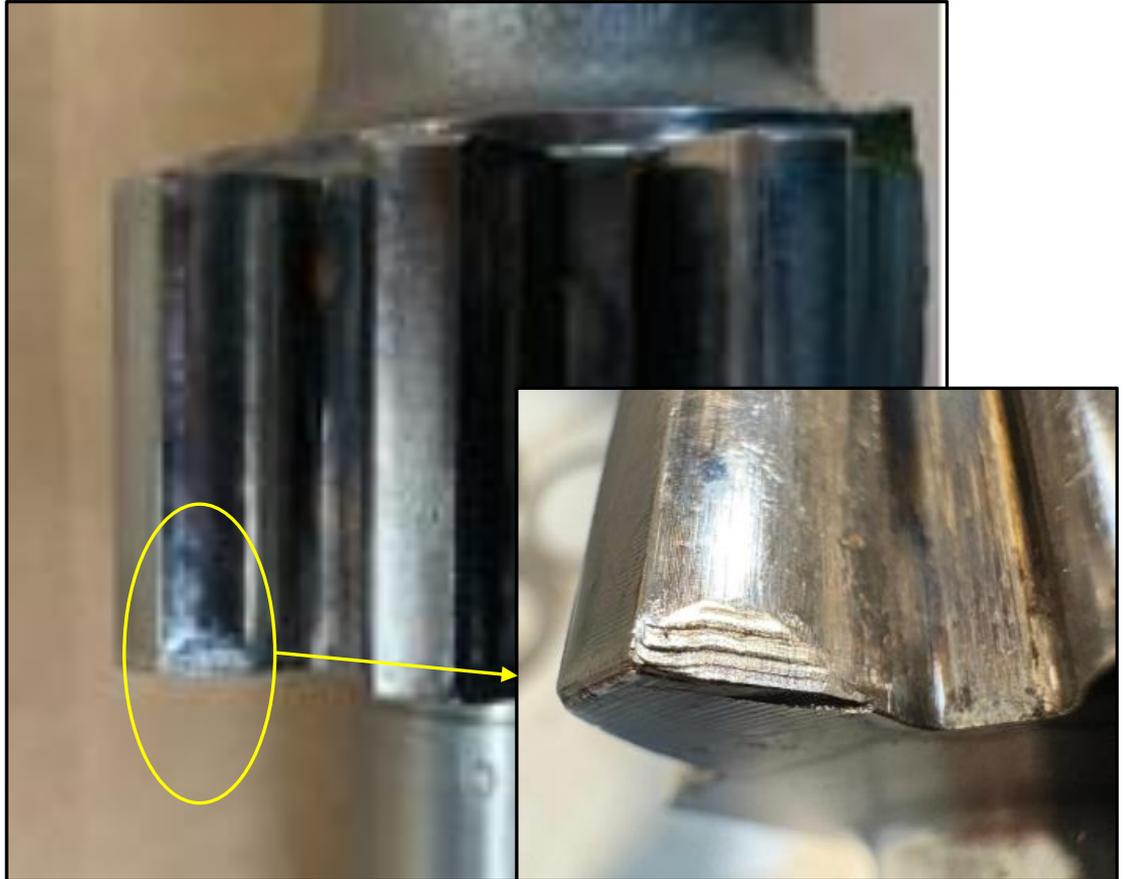
Sector Shaft Damaged Tooth. Possible Re-assembly Issue

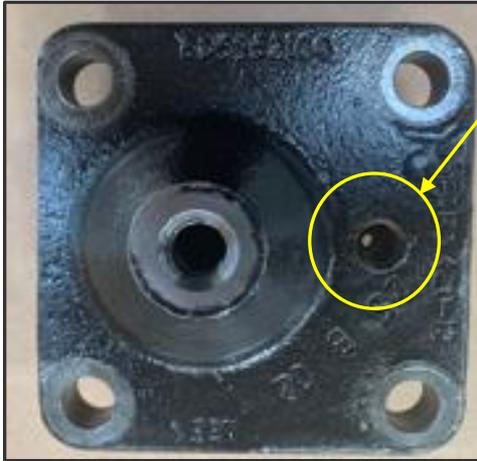
Cover Plate Condition - Not Acceptable

With test rig at idle pressure, Steering gear wound lock to lock to sweep fill. n.b unable to vent air from Steering gear from bleed screw. Completely rusted. Required was removal.

Bleed Screw and Hole Full Of Rust

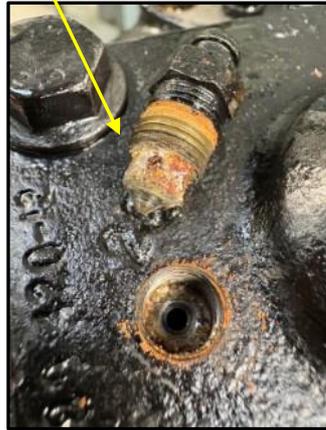
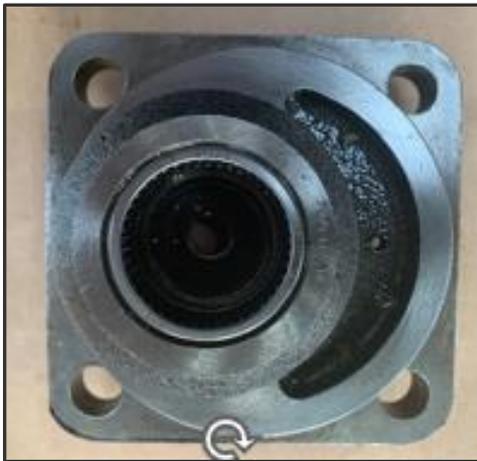
Cover Plate Seal Is Not OE Specified Seal

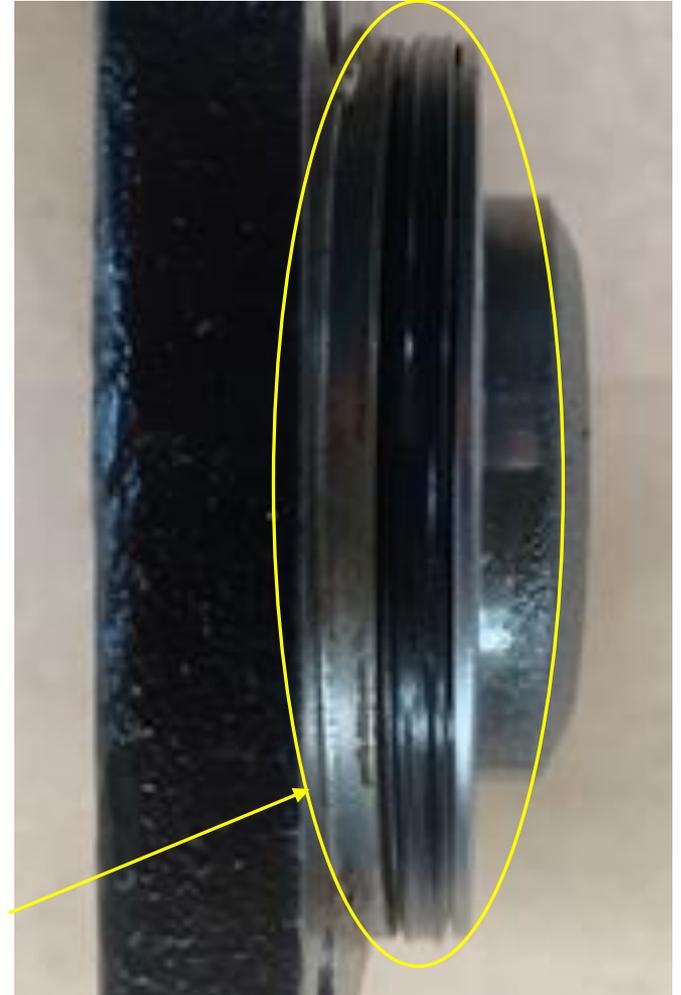
Cam Adjuster Condition – Not Acceptable

**Square Section Seal
Is the Original Seal fitted. Not replaced With
New**

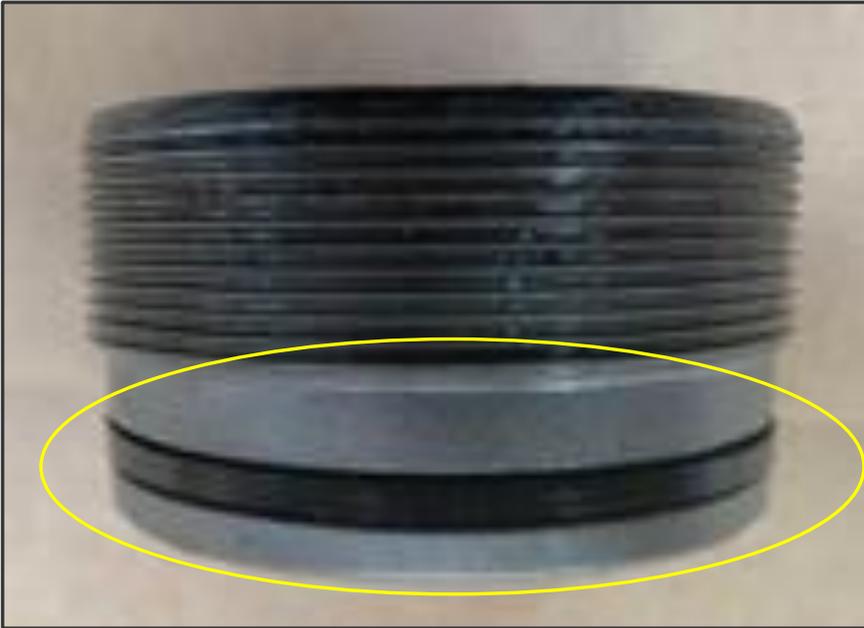
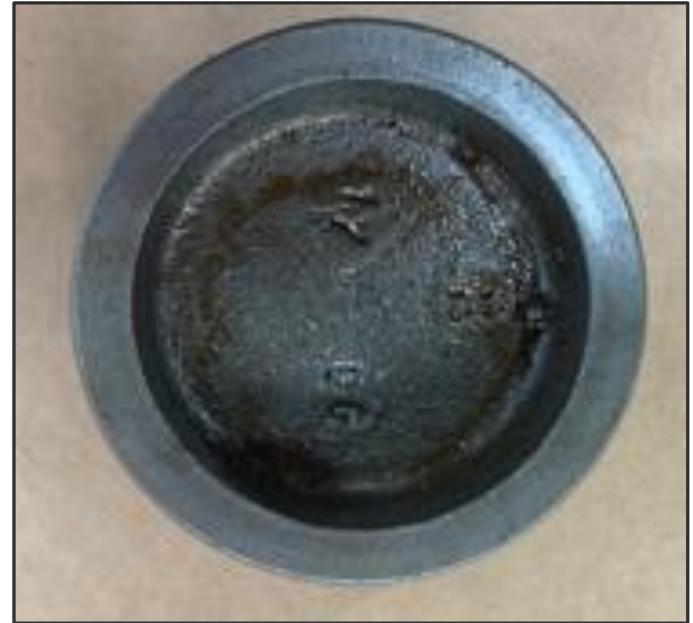
Piston Cap Condition – Not Acceptable

**Square Section Seal
Is the Original Seal fitted
Not replaced With New
Damaged**

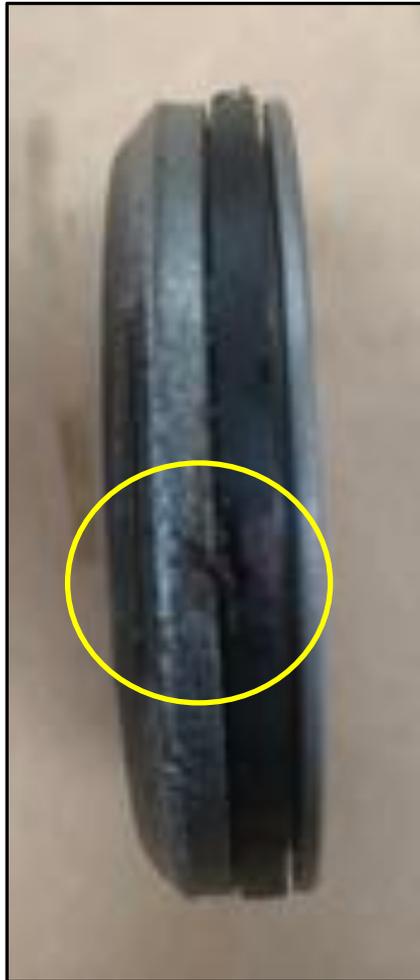
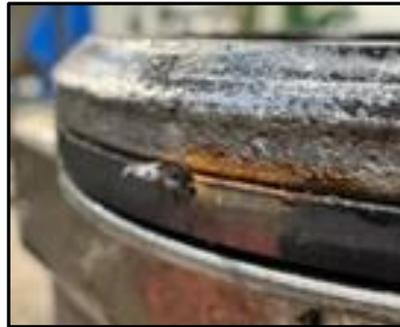
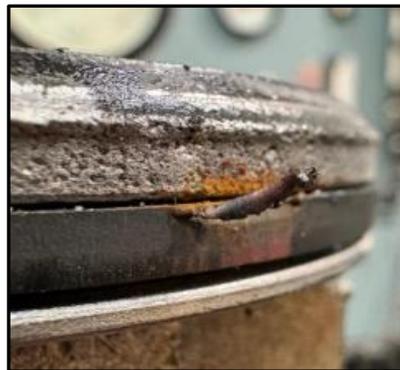
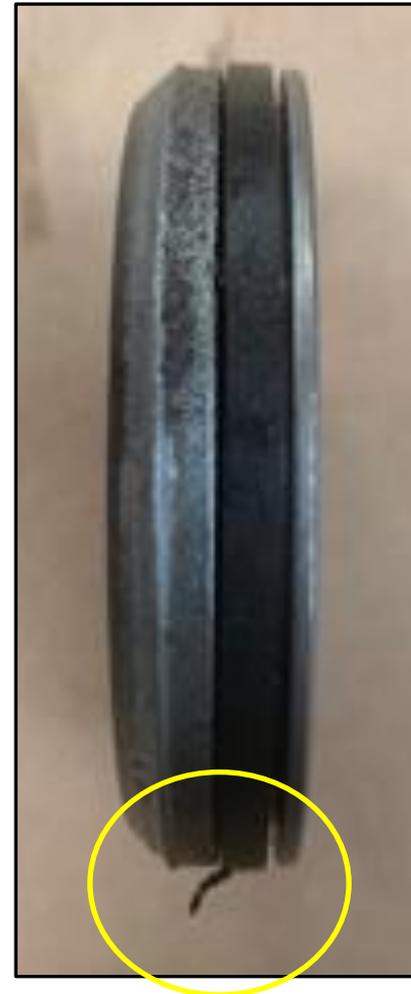
Piston Rack Condition – Not Acceptable

**Teflon Seal
Is the Original Seal fitted
Not replaced With New**

**Teeth Condition
Satisfactory**

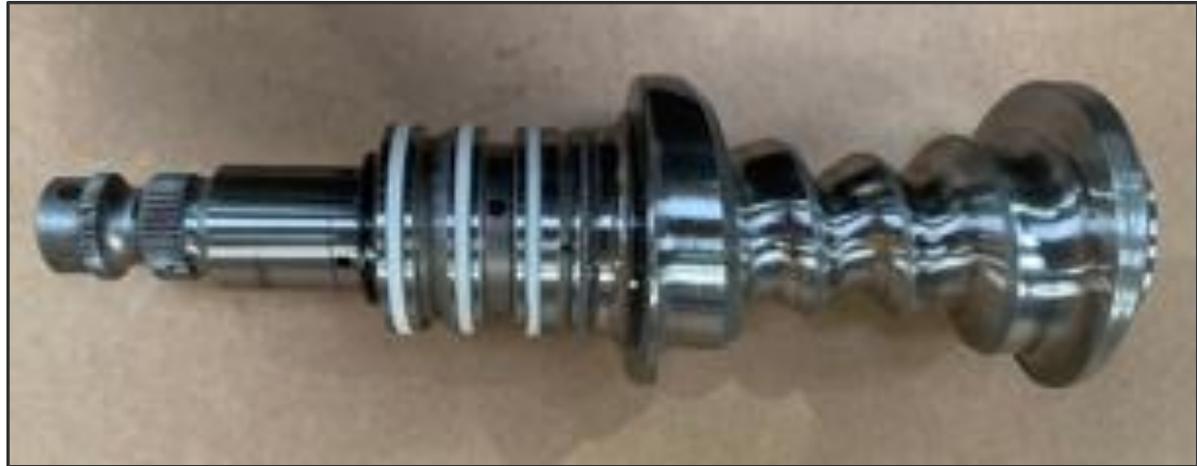
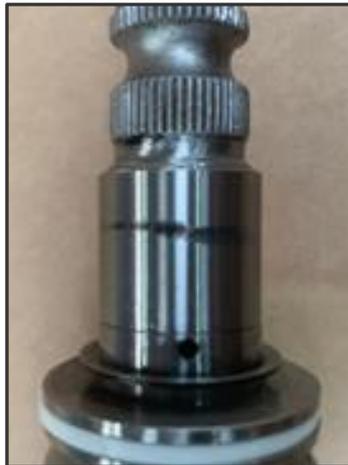
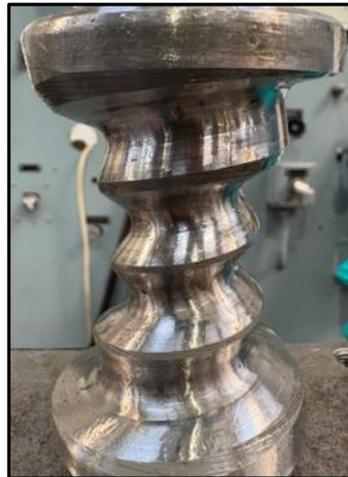
**Teflon Seals
Is the Original Seal
fitted
Not replaced With
New**

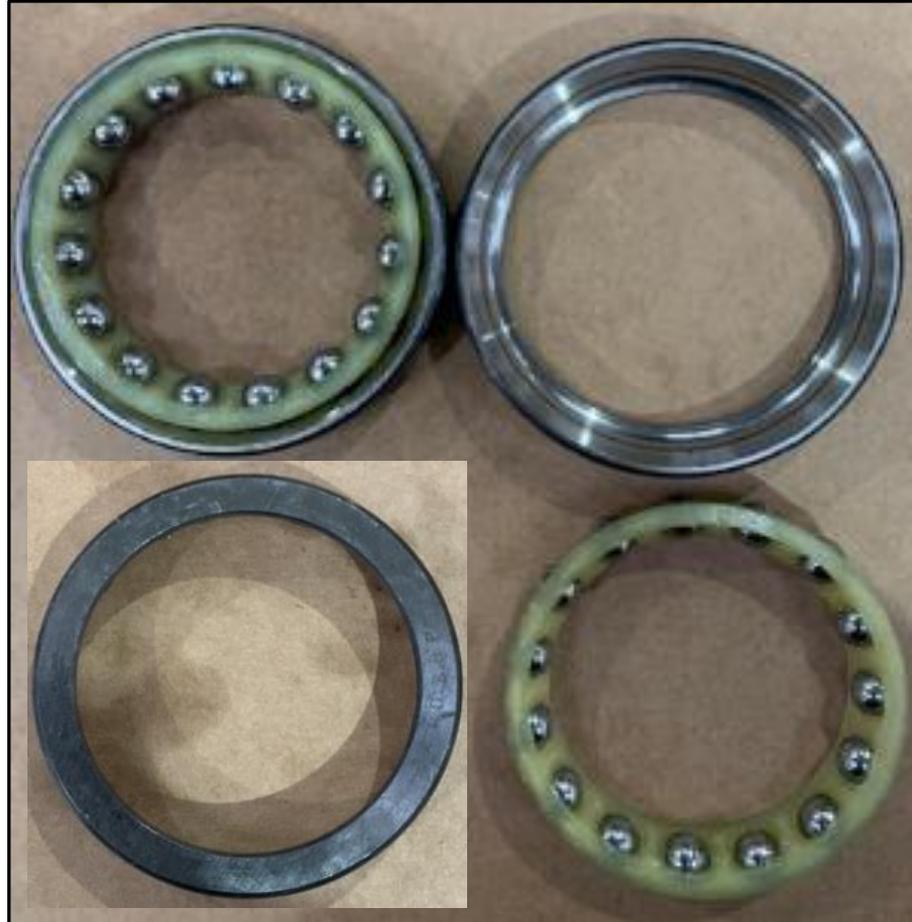
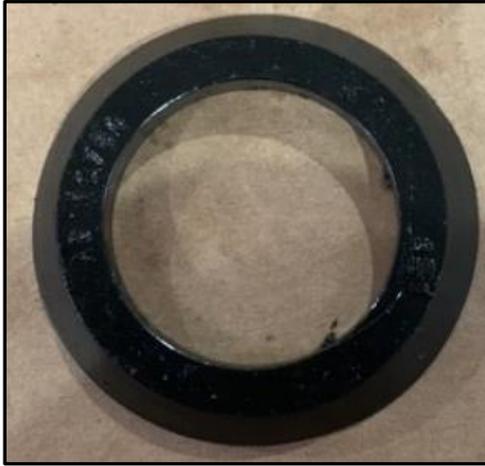
Output Shaft Dirt Seal Condition – Not Acceptable

**Dirt Seal
Supplier Not Known**

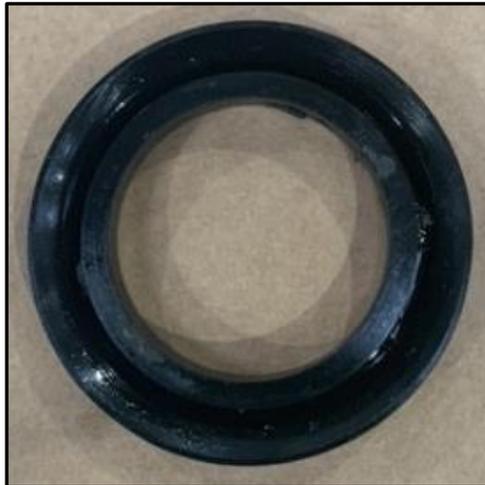
**Fitment Of Dirt Seal
Not Seated Correctly Allowing Dirt Ingress**

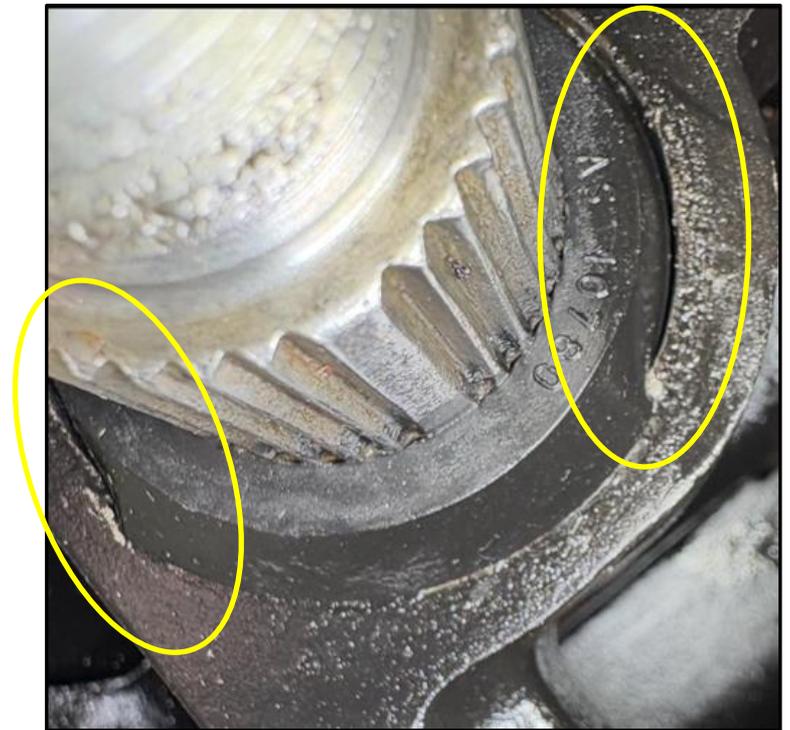
Output Shaft Seal Condition – Not Acceptable

**Sector Shaft Output Pressure Seal
Supplier Not Known
Hardened Unidentified Sealing Compound being used**

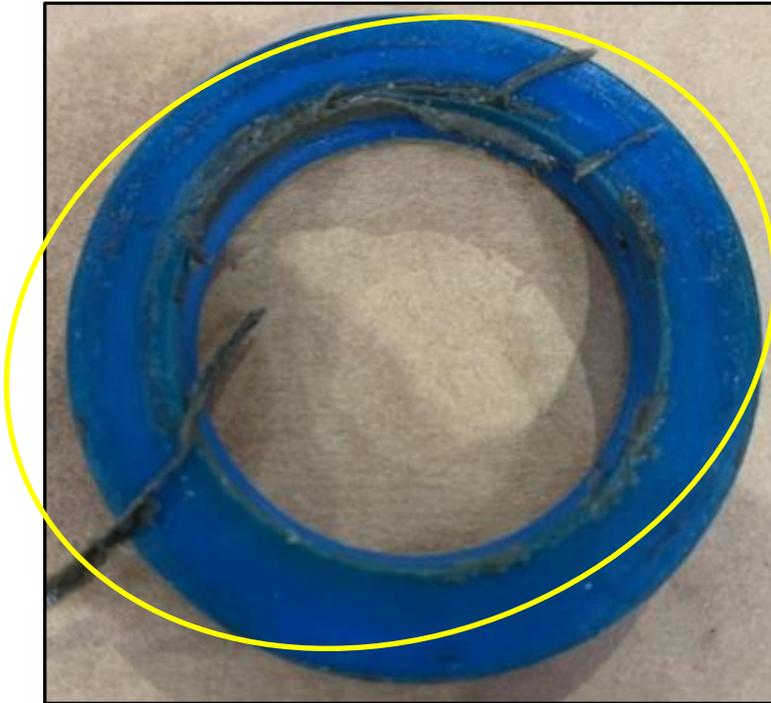
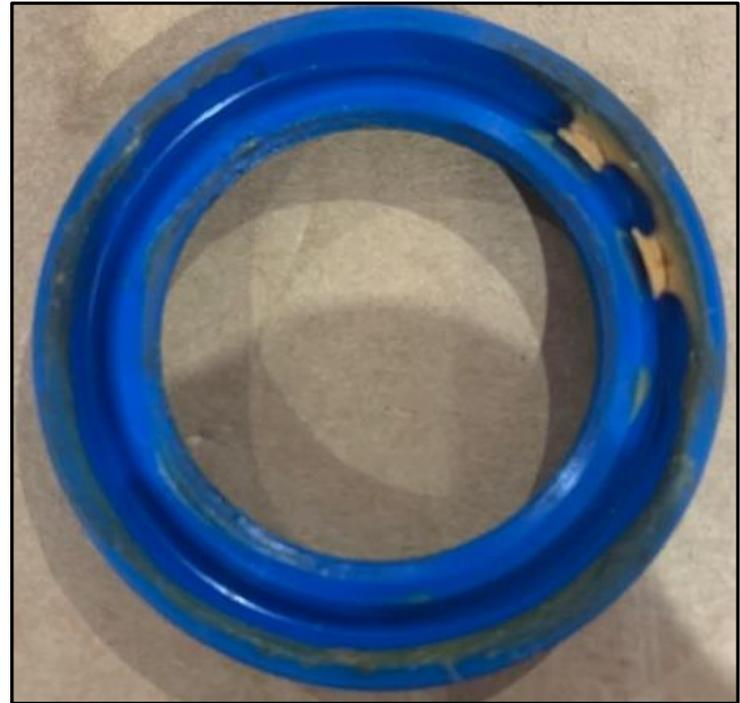
Output Shaft Seal Condition – Not Acceptable

**Sector Shaft Output Backup Seal
Supplier Not Known**
